**Technical Service
BULLETIN**

**VSC STEERING ANGLE SENSOR
INITIALIZATION DURING PDS OR
AFTER REPAIR**

**'05 Scion xA & '04 RAV4, Scion xB, Tacoma
& Tundra**

STEERING
ST005-04

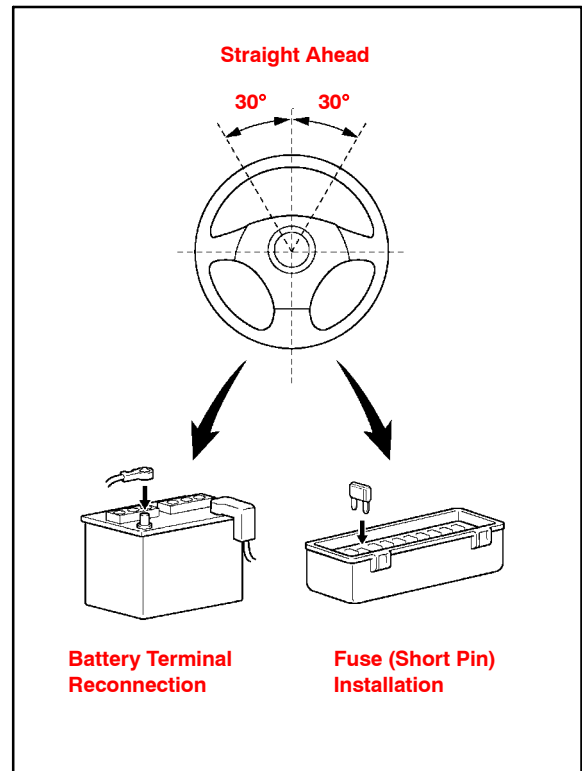
1. With the ignition in the off position, disconnect the negative terminal of the battery.
2. Check that the steering wheel is in the straight-ahead position (± 30 degrees from straight ahead). If the steering wheel position is more than ± 30 degrees from straight-ahead position, turn the steering wheel to the straight-ahead position.
3. Install the fuse/short pin and reconnect the negative terminal of the battery.
